From: Frey, Rebecca
Sent: Tuesday, July 26, 2016 11:01 AM
To: Moynihan, Colleen
Subject: FW: Ten Mile Drain interim action- remove and replace vaults
Attachments: DSCN2260.JPG; DSCN2273.JPG; DSCN2259.JPG; tenmiledrain-irod-2014.05.pdf

From: Moynihan, Colleen
Sent: Monday, August 31, 2015 11:44 AM
To: Frey, Rebecca
Cc: Kowal, Kathleen; Dytrych, William
Subject: Ten Mile Drain interim action- remove and replace vaults

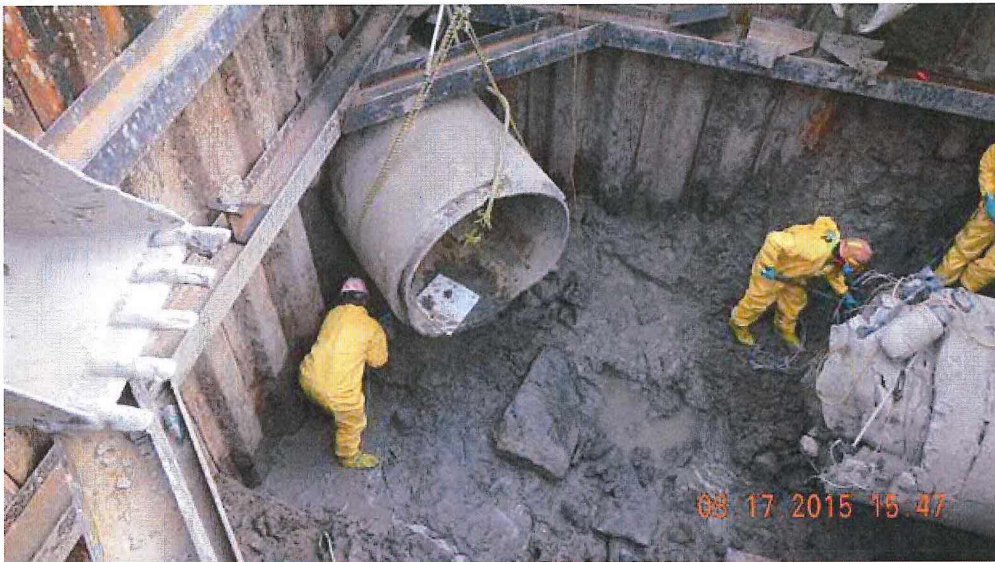
The first embedded photo in the email was taken at 7179 on 8/17/15- manhole vault removed and pipes exposed in the excavation pit about 18 ft below grade. The pipe on the left in the photo extends towards Harper and connects to J01. You can see the 2 inch thick liner extends beyond the pipe and is really detached from the pipe at end.

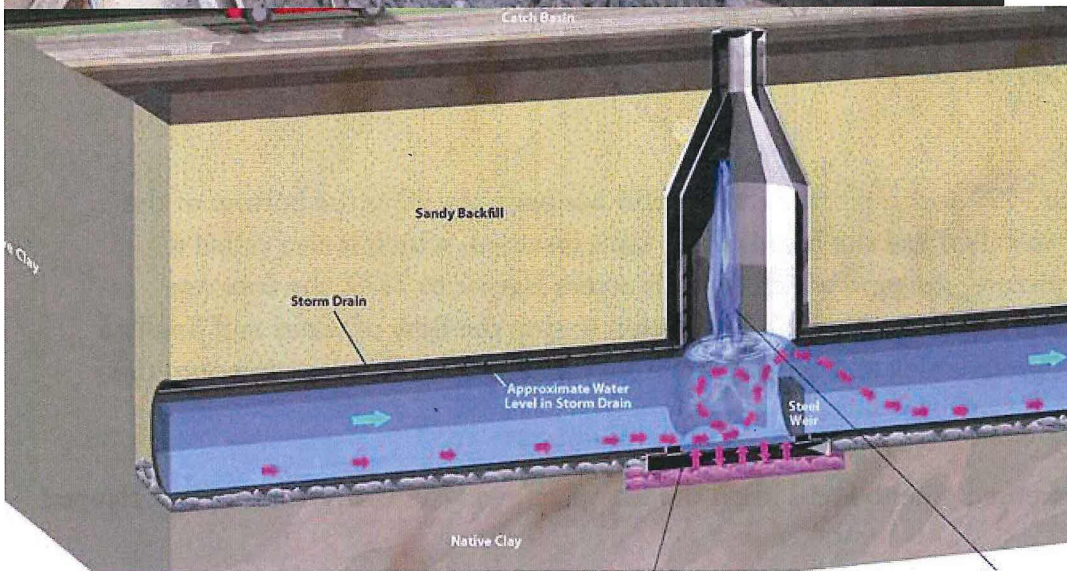
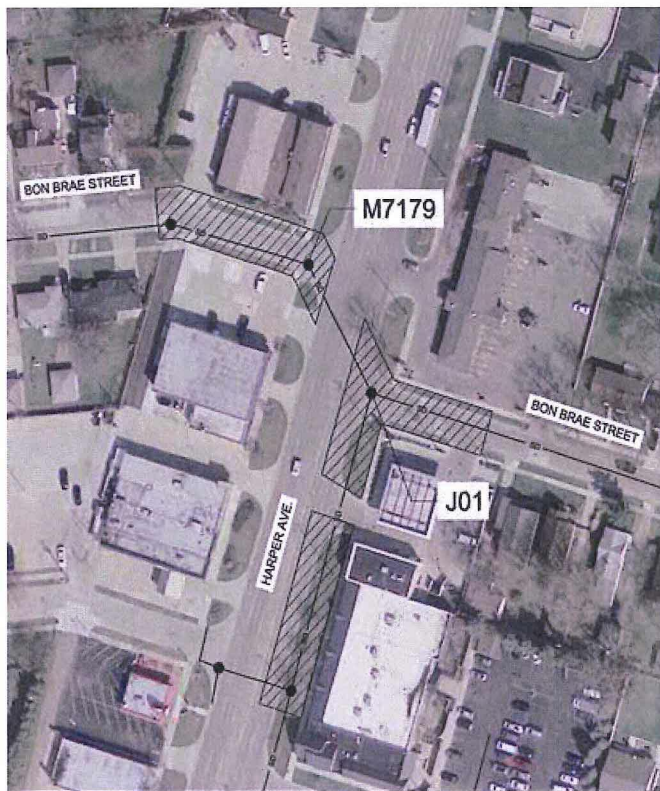
The two figures also embedded in the email help in presenting the photos- shows a graphic of the vault and the second figure shows where 7179 and J01 are located.

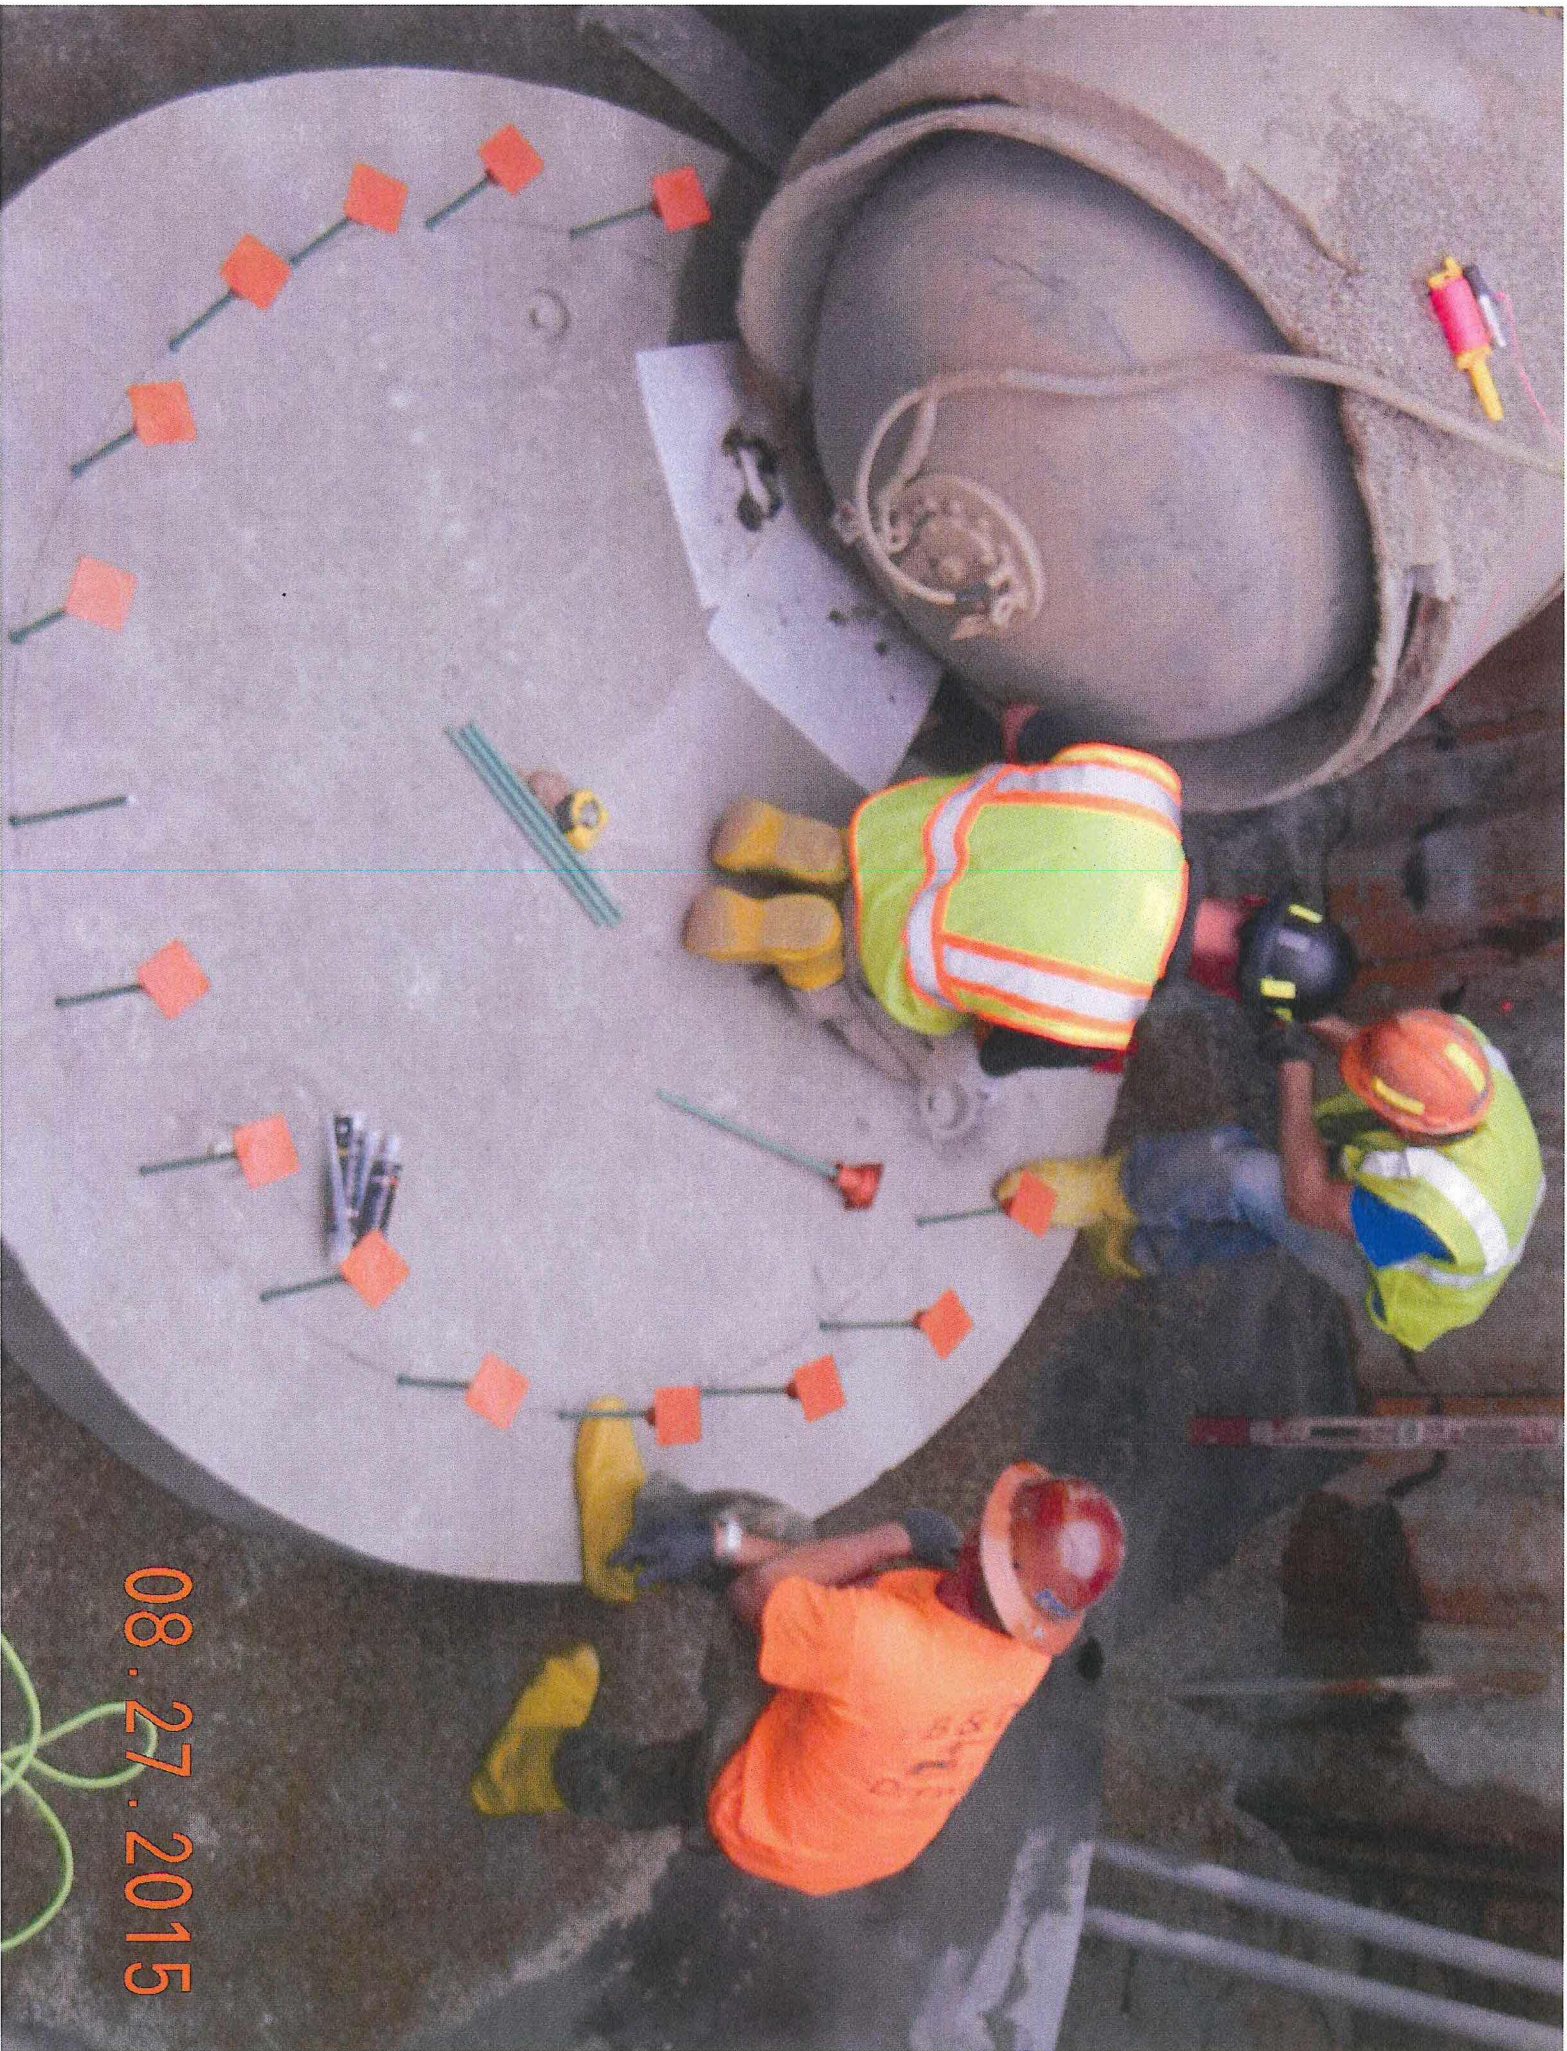
08.27.2015

DSCN2260- A picture taken at 7179 at this point clean backfill has been placed at the bottom of the excavation pit, then the liner installed and the based of the vault installed, which is also called a "cookie". You can see in this picture, the pipe which extends across Harper to 7179, the concrete cookie, the plug-which is placed inside the pipe as a precaution to stop the flow of water and finally a closer look at how the liner is pretty thick and is detached from the pipe and oil is dripping onto the absorbent pads.

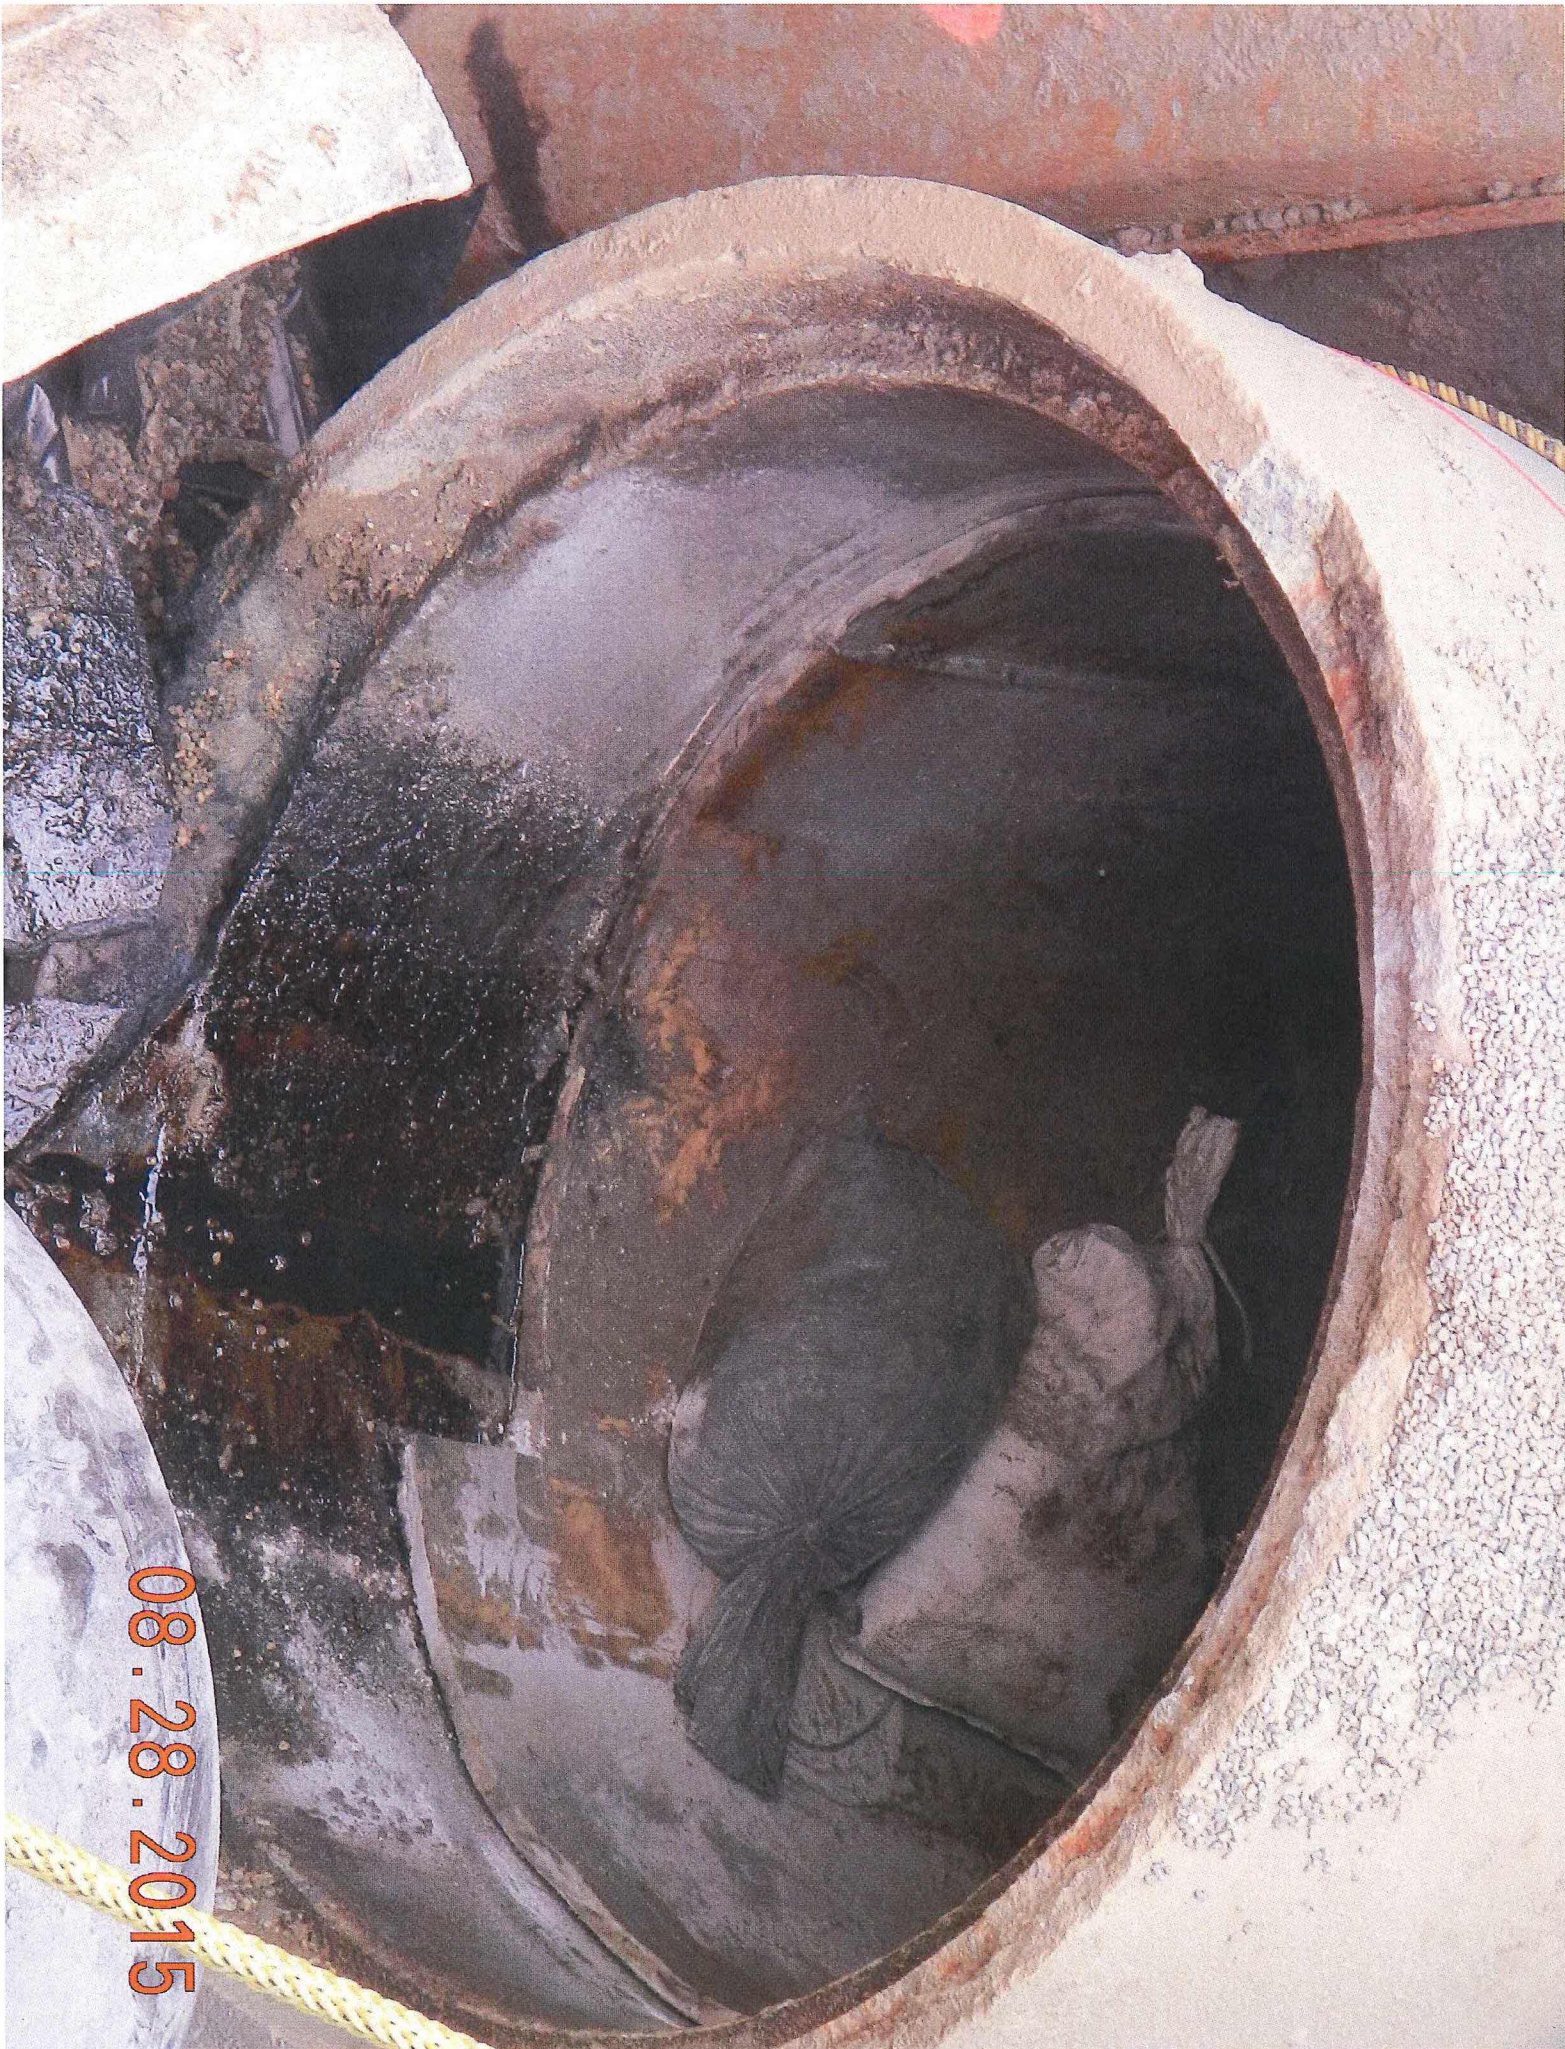
08.28.2015

DSCN2273- picture taken on Saturday at 7179 at the pipe that extends across the street to Harper. The subcontractors cut a piece of the liner out- oil streamed out from between the pipe and liner and was captured by absorbent pads. As of today, the oil continues to drip and leak from between the liner and pipe onto the absorbent pads.

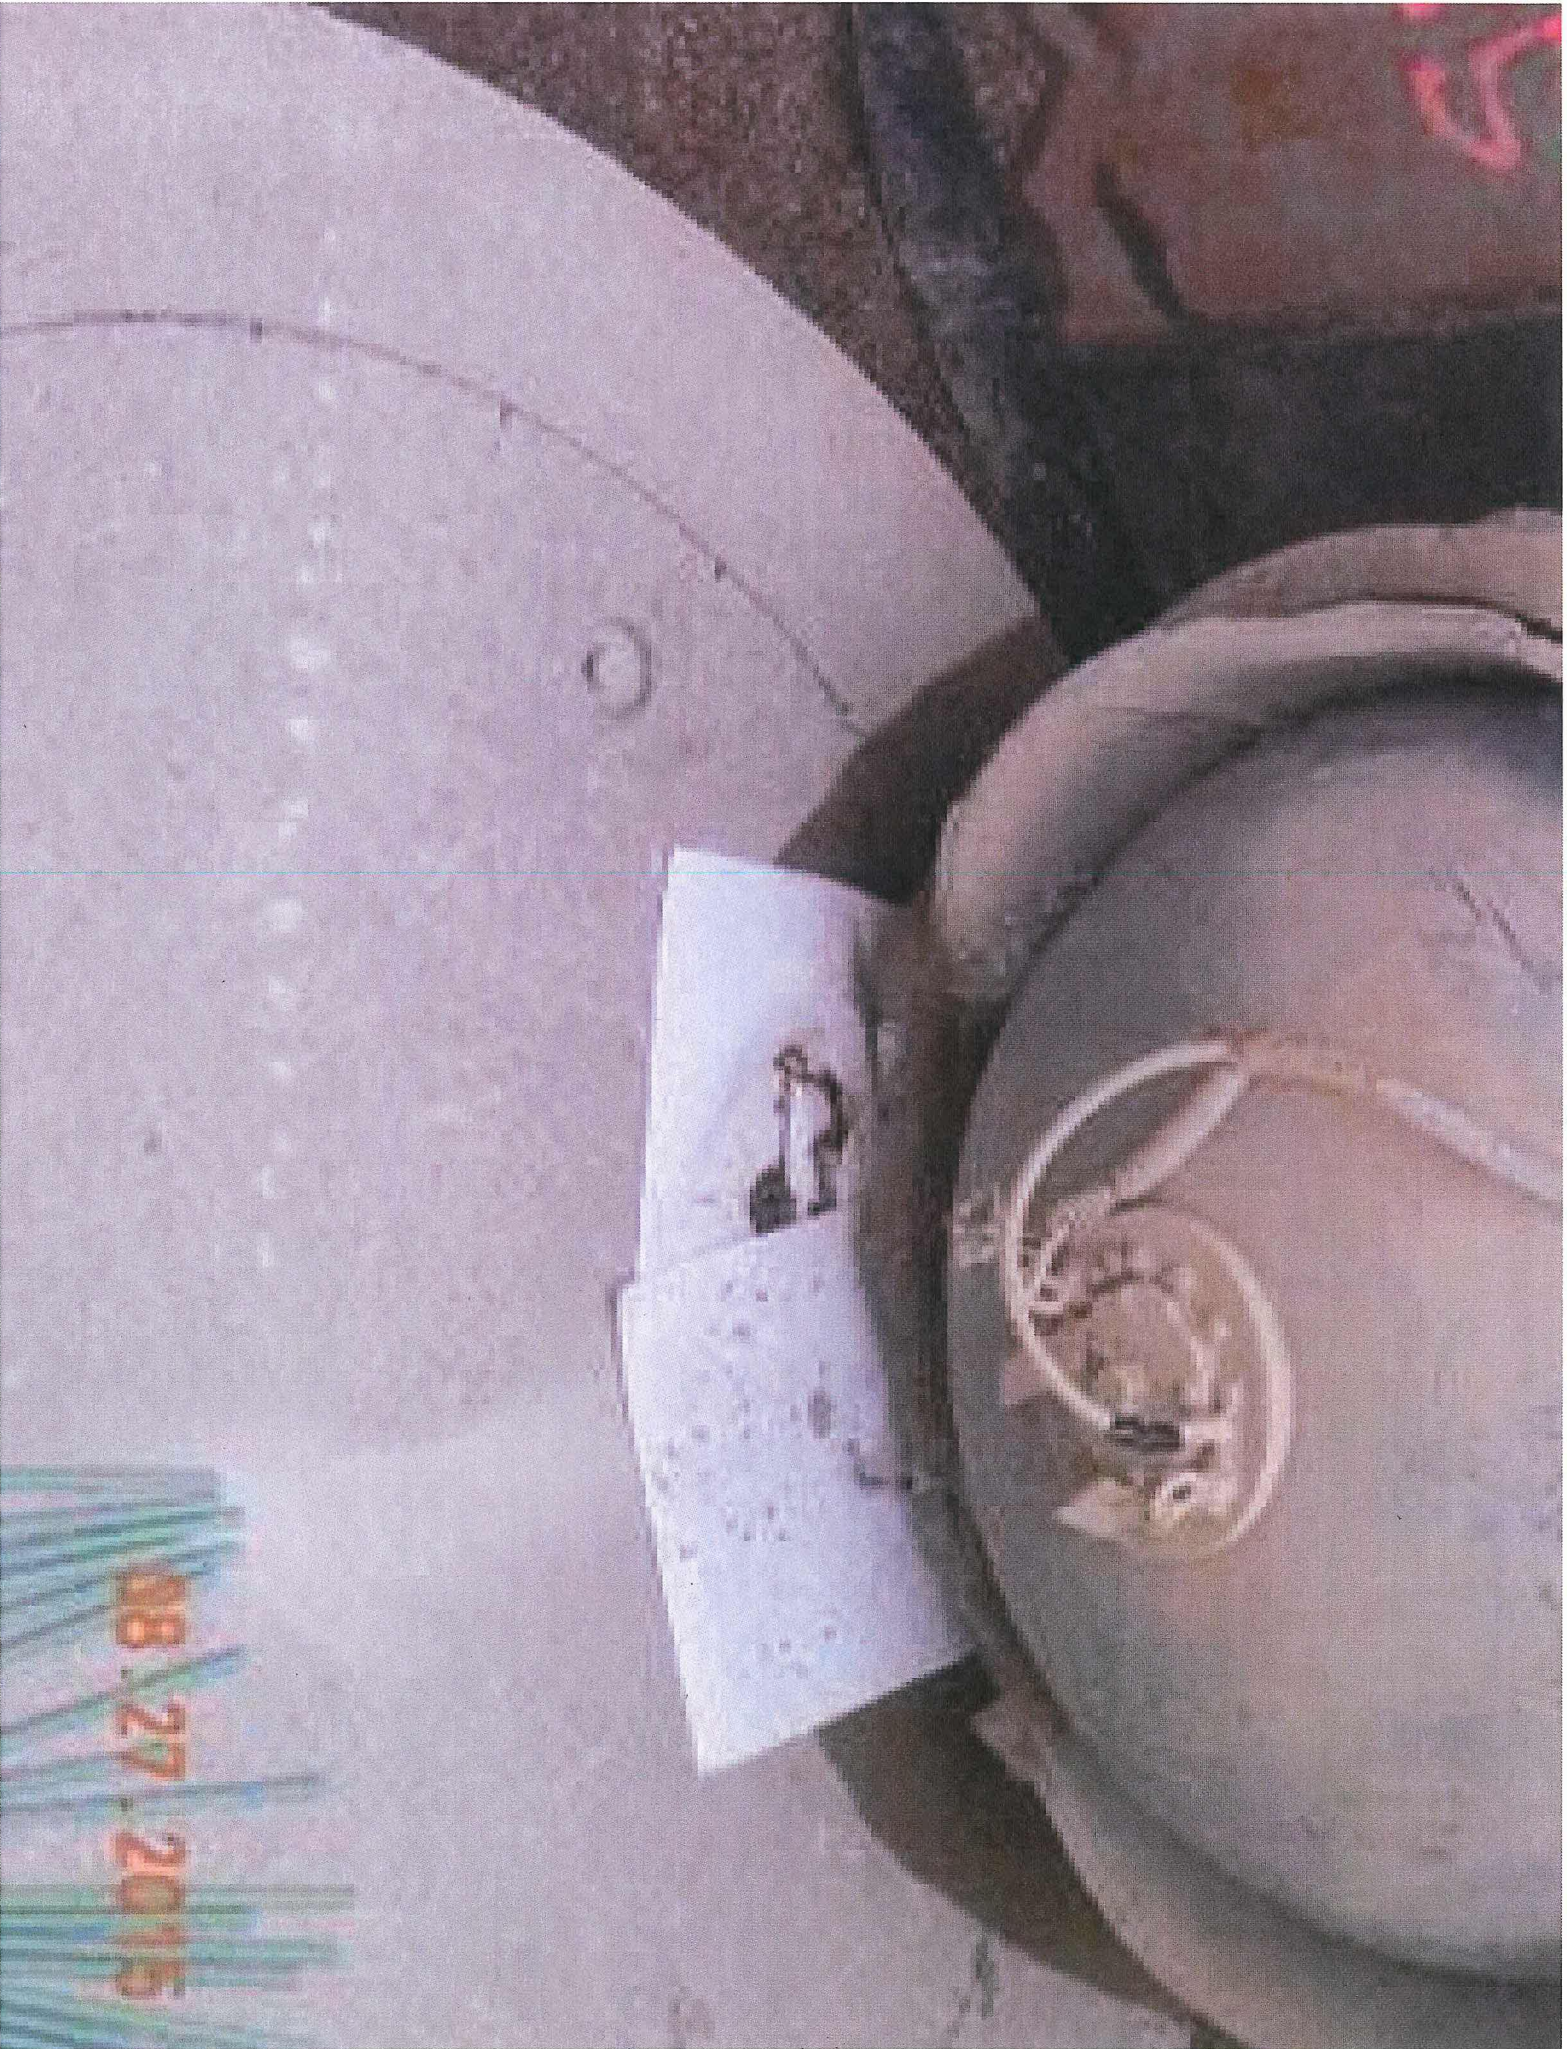
08-27-2015

DSCN2259- Zooms into the exposed pipe to focus in on the leak. Plus, you can really see the liner flapped outside of the pipe.
